Navajo Abandoned Uranium Mine Site Screen Report

Brown Vandever Mine

Navajo AUM Eastern Region

May 2009

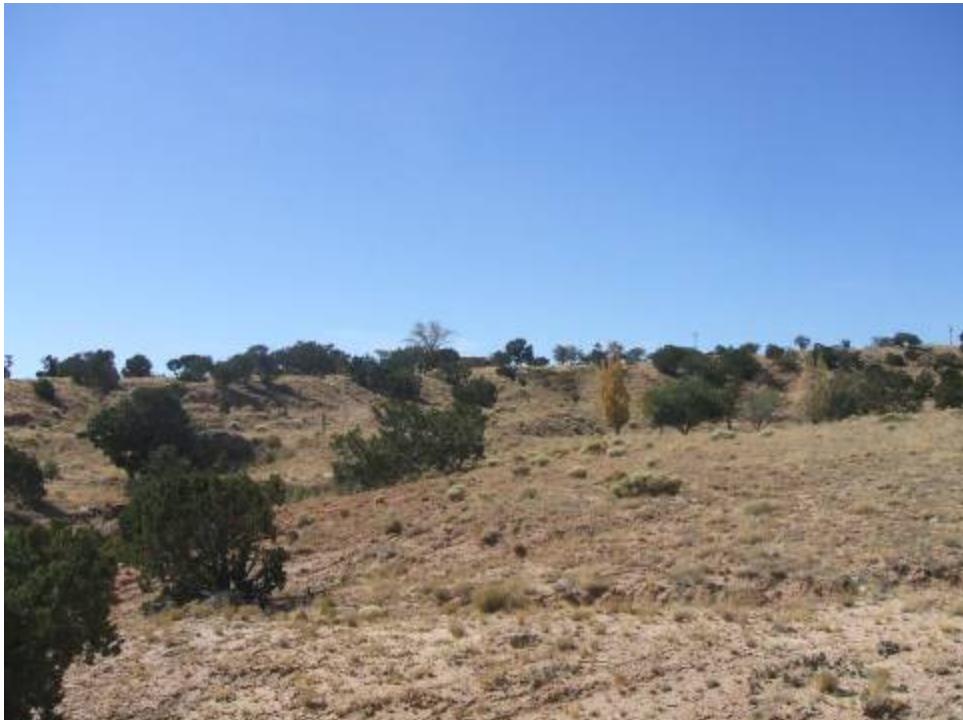
Photo 1. Section 18 mine site, towards the south

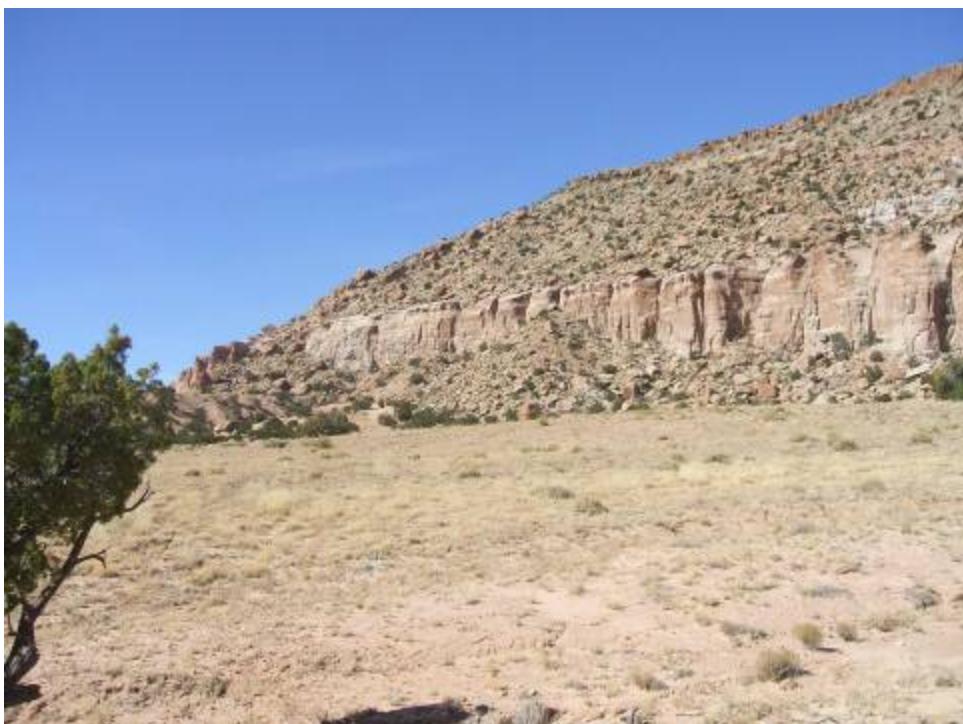
Photo 2. Section 18 mine site, towards the northwest

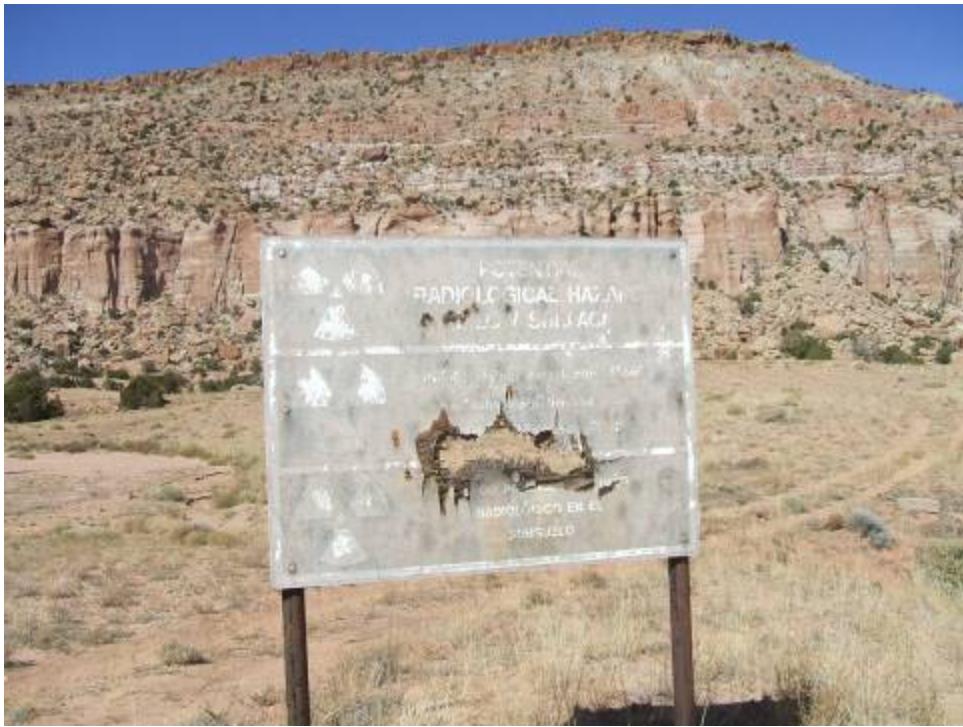
Photo 3. Section 18 mine site ‘Potential Radiological Hazard’ sign, towards the north

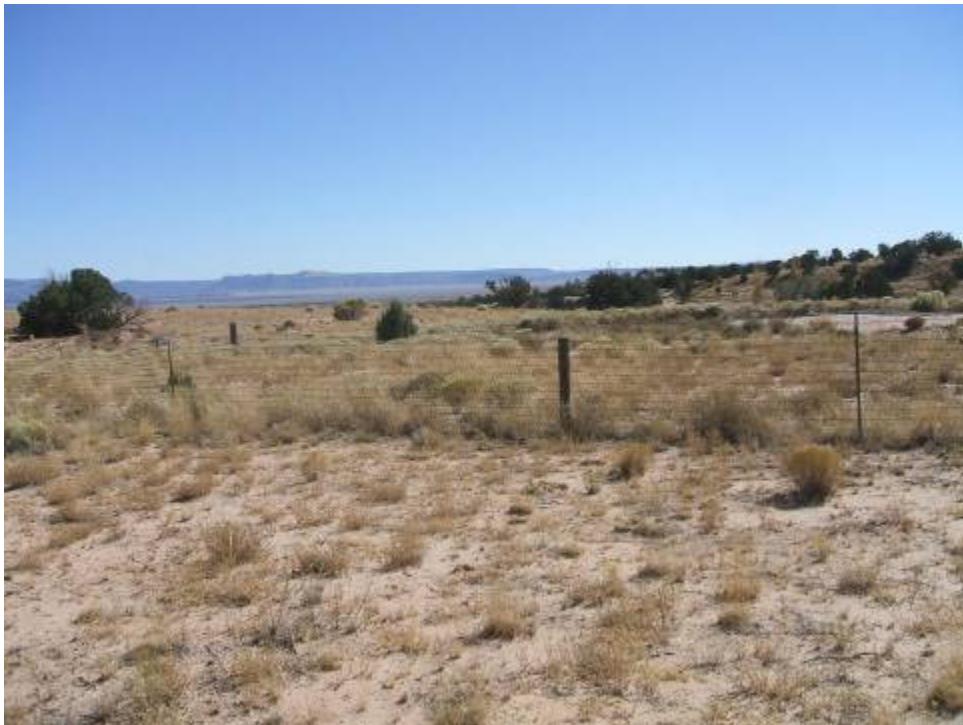
Photo 4. Section 18 mine site fenced enclosure, towards the east

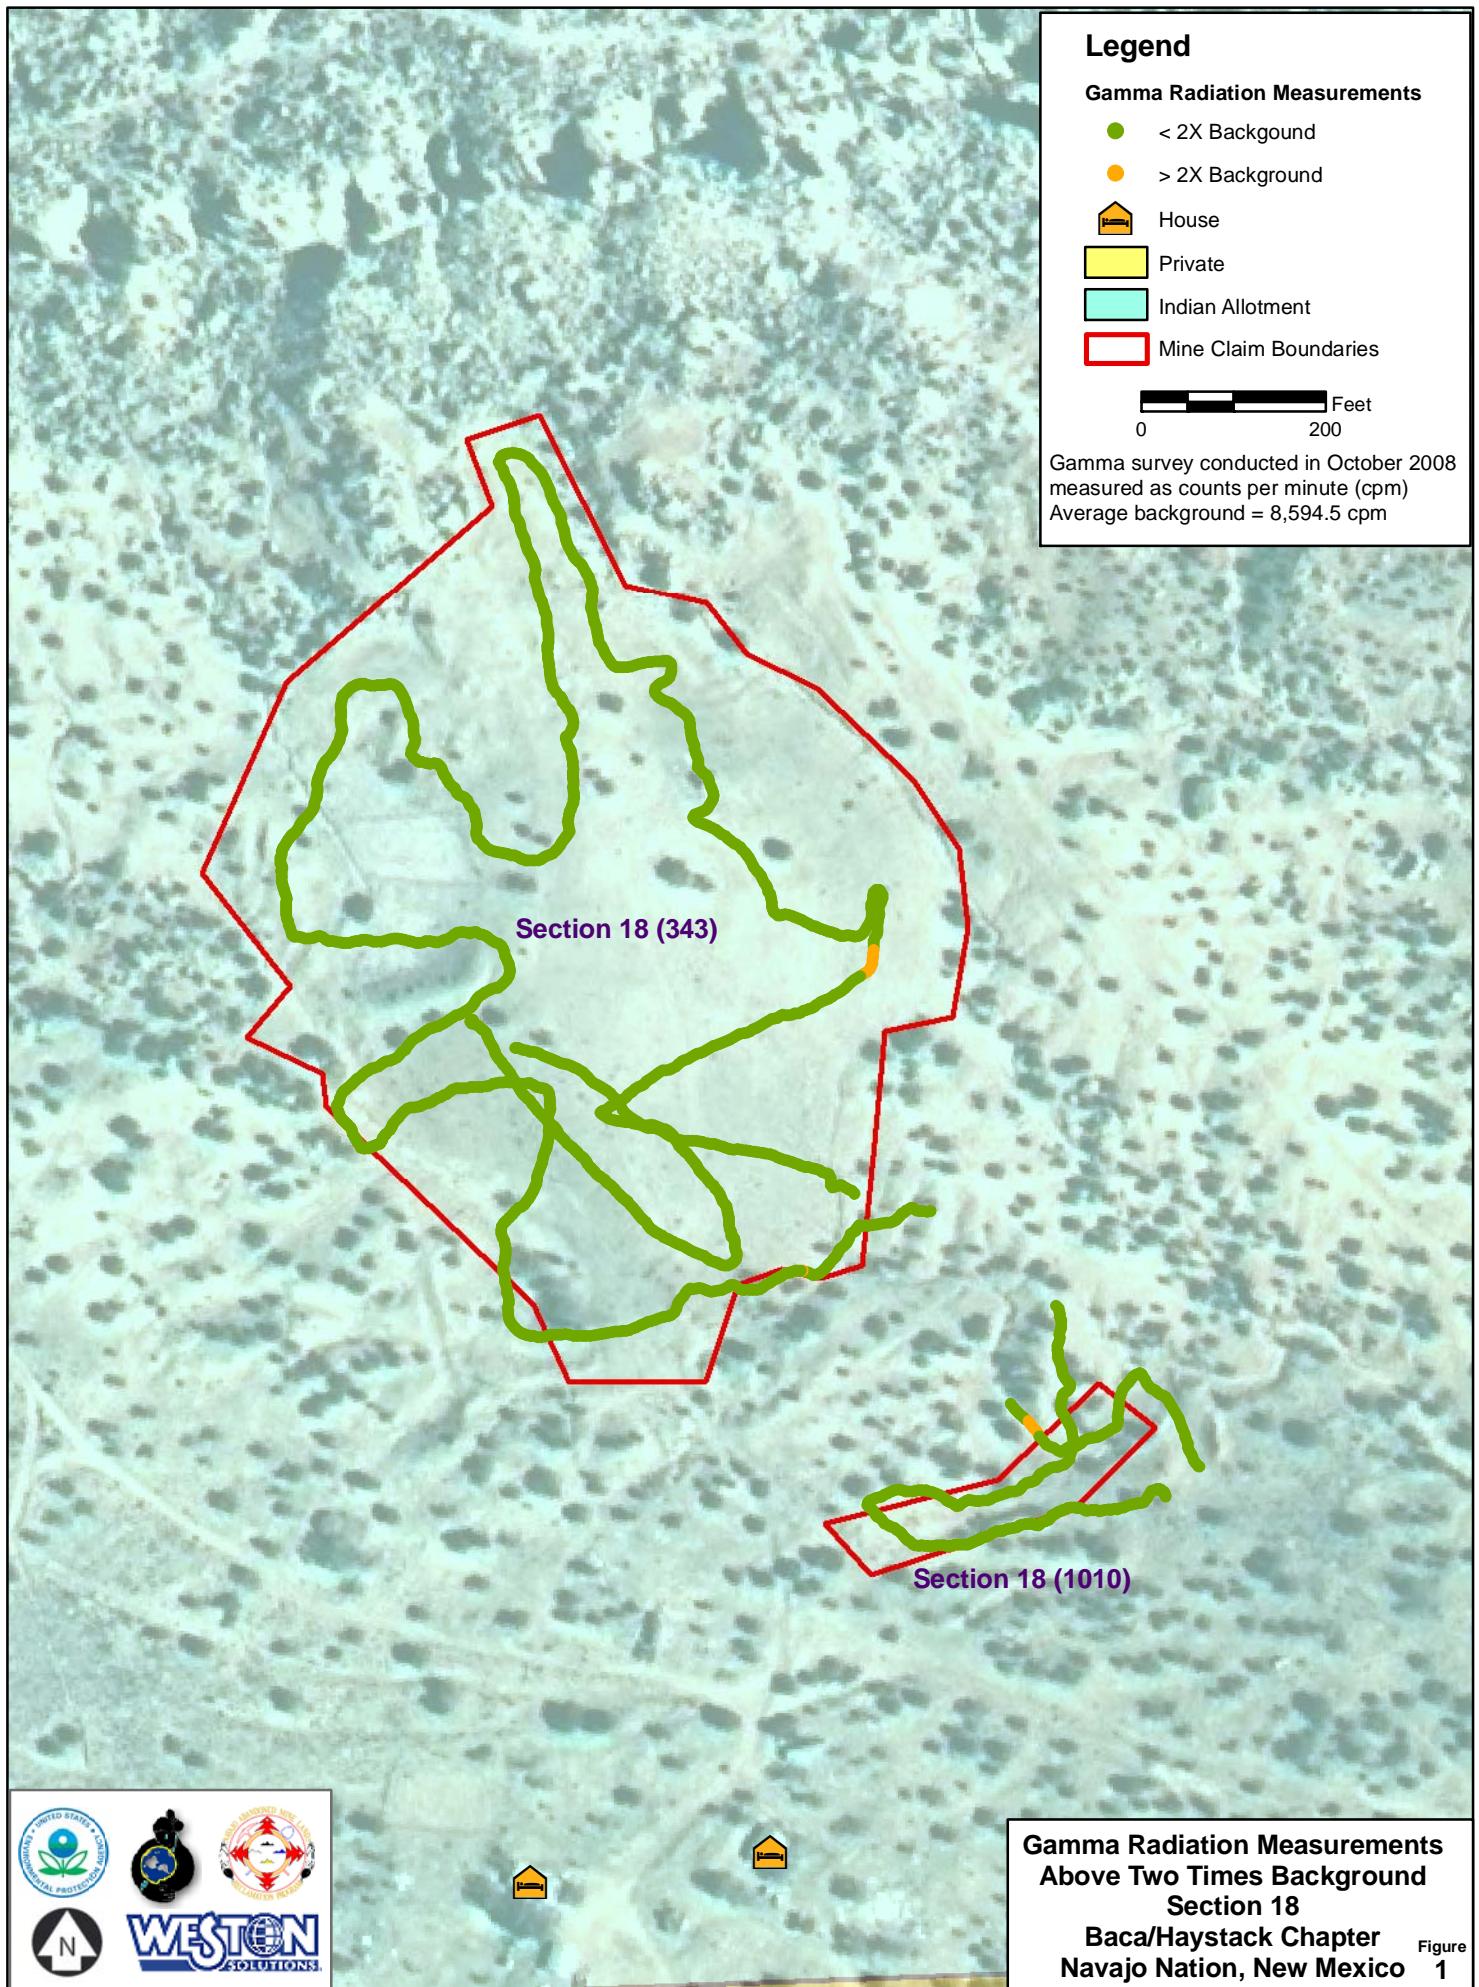
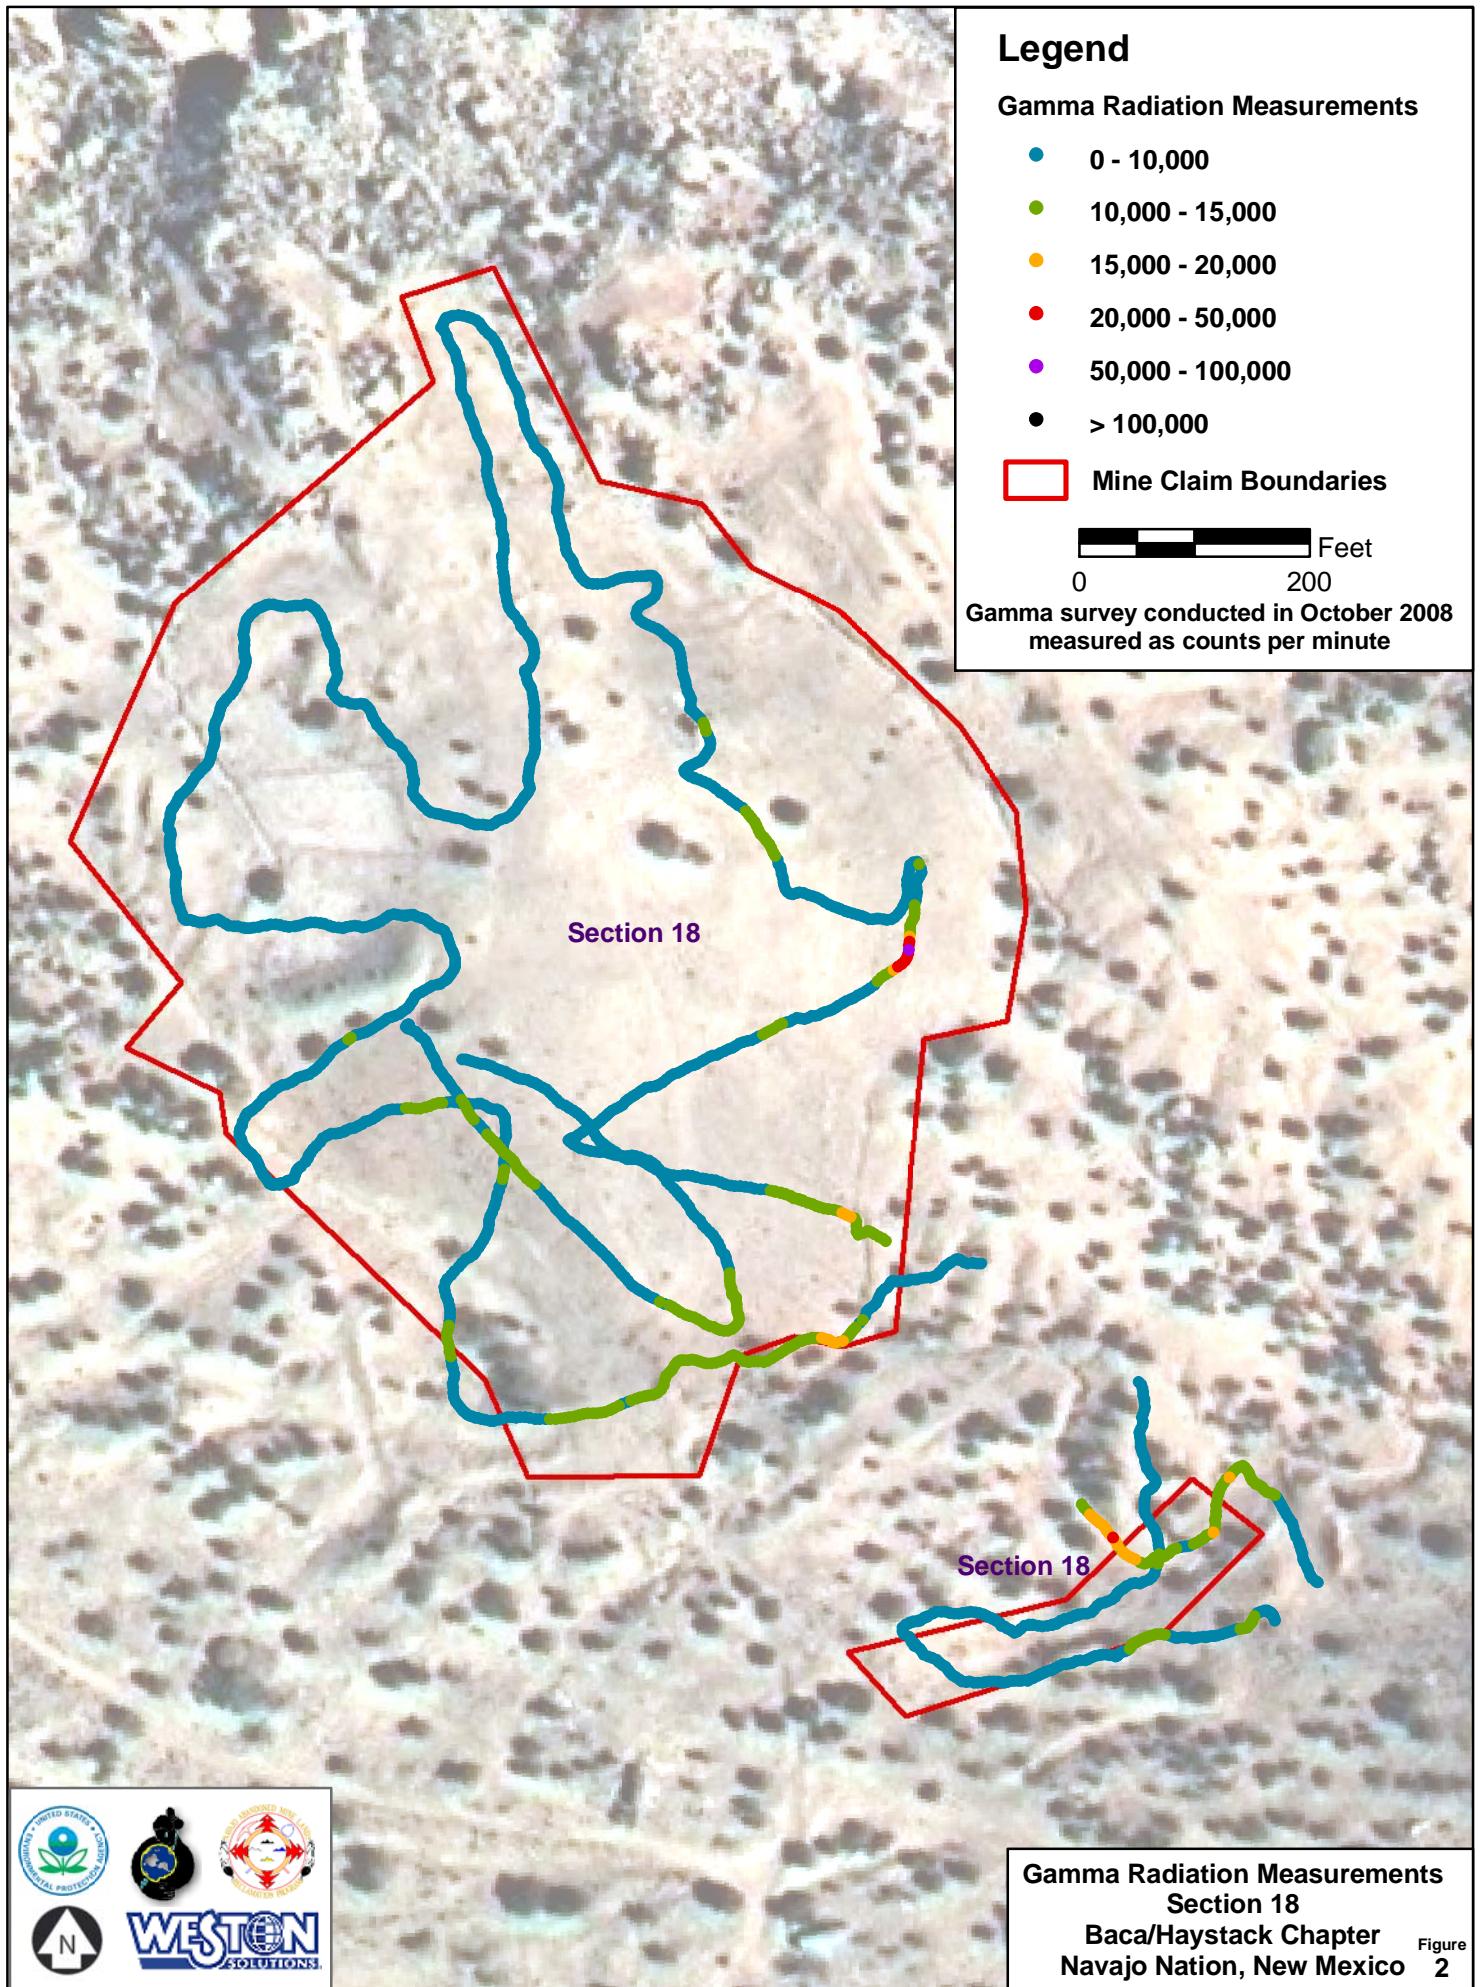
A total of 1,825 gamma radiation measurements were collected from mine sites, ranging from 6,618 cpm to 56,343 cpm. The measurements are represented in Figures 1 and 2. The New Mexico Mining and Minerals Division identified radiological measurements with background levels 90-130 counts per second (cps); adits 3,900 cps; and stope 3,500 cps.
